# Docent Dispatch

January 2017

## Carlyle House Architecture

By Susan Hellman

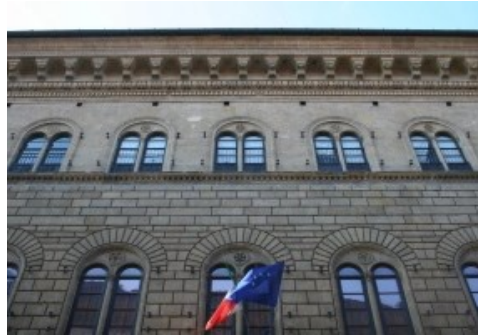
one of the architects who worked on the 1970s restoration, the lowest portion of the exterior wall, from the water table to the ground, was originally rusticated. Rustication is a type of masonry treatment in which the blocks making up a wall are articulated by exaggerated joints rather than being

flush with each other. The material is generally left rough, emphasizing massing. The Palazzo Medici Riccardi in Florence, depicted above, has lower-level rustication.

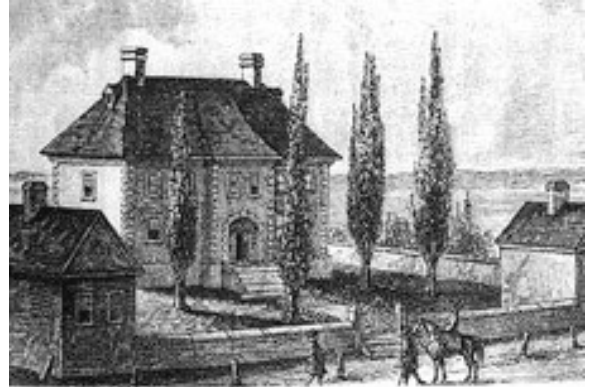
Carlyle's outbuildings stood apart from the house, as shown in the 1880s image from *Harper's*. Although a great deal of archaeological evidence was lost, we know that Carlyle House originally had several outbuildings, including an office and a kitchen.
